# MARKETING BULLETIN

## REPAIRING DAMAGE/DEFECTS IN A 2-HOUR AREA SEPARATION WALL SYSTEM

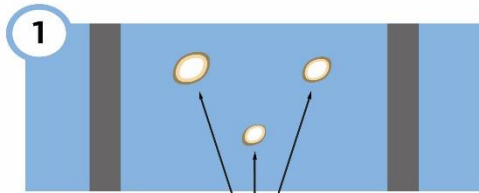
**ISSUE:** After the ASW System is installed, damage can occur to the face of the 1" Shaft Liner panels. This damage can be caused by falling lumber, hammers, carts, etc., and while not fracturing or penetrating these panels, this damage can be up to 1/2" to 5/8" in depth.

**1**  
Dents or damage to Shaft Liner panel

- ❖ Indentations or damage to the face of 1" Shaft Liner panels (maximum 1/2" to 5/8" in depth) is filled with 3M Fire Barrier Sealant CP 25 WB+ fire caulk
- ❖ Smooth out fire caulking with putty knife or like tool
