TECHNICAL SERVICES BULLETIN

REPAIRING DAMAGE/DEFECTS IN THE 2 ½ HOUR ME AREA SEPARATION FIREWALL SYSTEM

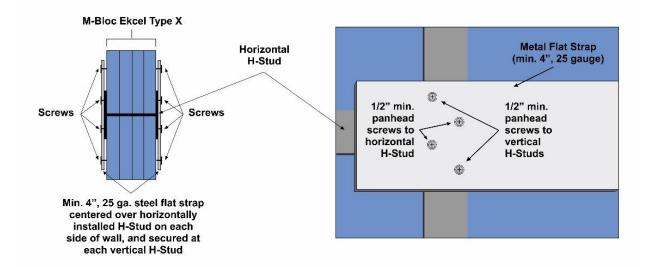
H-STUDS INSTALLED HORIZONTALLY IN THE ME AREA SEPARATION FIREWALL SYSTEM

At times during the installation of the ME Area Separation Firewall System, a framing crew will mistakenly install an H-Stud horizontally - instead of the required 2" C-Runner Track, to cap or finish off a wall section. This error during installation does void the fire rating of the ME ASF system, but American Gypsum - working with UL, has developed the following corrective action to restore the 2 ½ hour fire rating.

When "H" studs are erroneously installed horizontally to cap the ME Area Separation Firewall in lieu of 2" C-Runner Tracks, do the following:

- ☐ As shown in the detail below, secure a minimum 4" wide metal flat strap (min. 25 gauge) the full length of the horizontally installed H-Stud on each side of the wall.
- ☐ Ensure that the metal flat strap is centered over the horizontal "H" stud, and attach with four (4) 1/2 in. min long panhead screws, at the location of the vertical H-Stud
- ☐ Two (2) of the screws are used to secure flat strap to vertical "H" stud
- ☐ The other two (2) screws are used to secure the metal flat strap to the horizontal "H" stud, in alternating pattern
