TECHNICAL SERVICES BULLETIN

REPAIRING DAMAGE/DEFECTS IN THE 2 ½ HOUR ME AREA SEPARATION FIREWALL SYSTEM

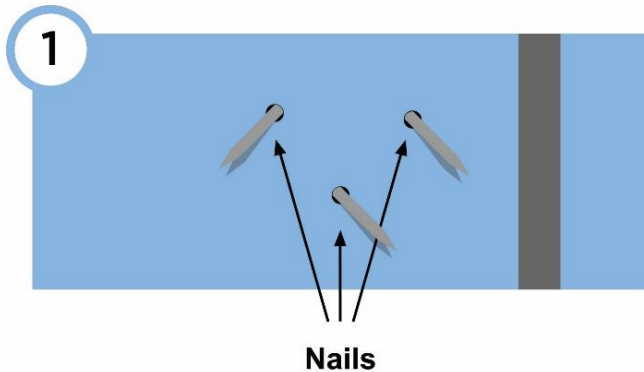
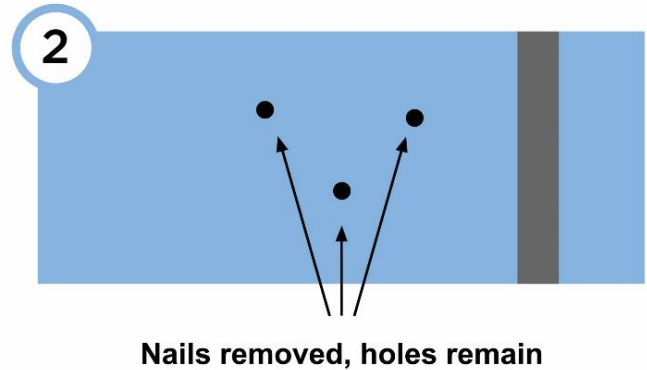
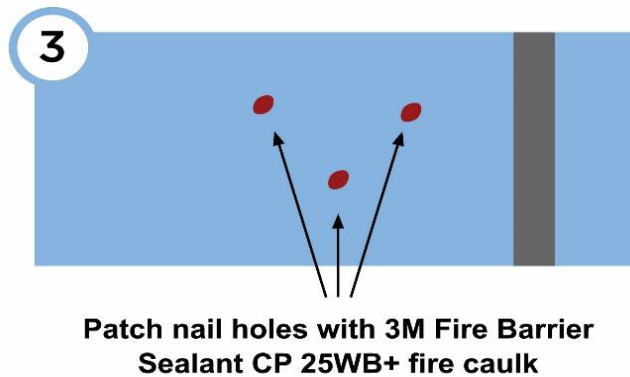
DAMAGE OR DEFECT:	NAILS DRIVEN THROUGH 1/2" M-BLOC® EKCEL® TYPE X with MOLD & MOISTURE RESISTANCE
--------------------------	--

ISSUE: Contractors have been known to drive or insert up to 16d nails into the 1/2" M-Bloc Ekcel Type X wallboard with Mold & Moisture Resistance when installing the ME Area Separation Firewall System. This practice voids the 2 ½ hour fire rating.

- REPAIR:**
- Remove the nails from the M-Bloc Ekcel Type X wallboard panels
 - Fill holes with 3M Fire Barrier Sealant CP 25 WB+ fire caulk (both sides of the wall where applicable)
 - Smooth out fire caulking with putty knife or like tool
