## GA-222-2019 REPAIRING SCREW OR NAIL POPS

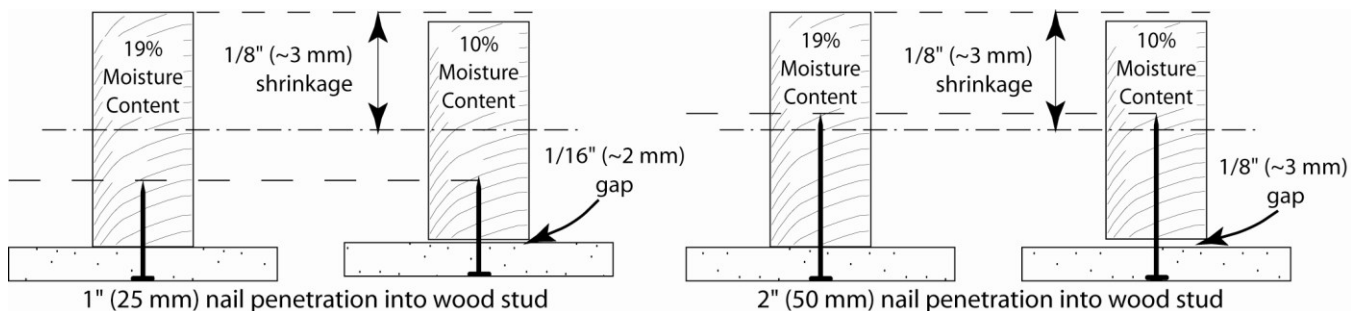
Fastener pops are largely caused by lumber shrinkage due to initial high moisture content in the lumber. Overly long fastener length contributes to the problem. Use fasteners that provide the minimum recommended depth of penetration into framing members. For fire-resistance rated systems, use fastener lengths specified in the listing.

Fastener pops can also occur with adhesive application of gypsum panels to wood framing when the construction adhesive exhibits unusually high shrinkage. This relatively new phenomenon is caused by the failure of water-based low-VOC drywall construction adhesives to cure and reach a dimensionally stable condition prior to finishing. To prevent this, it is important to confirm that the water-based adhesive is fully cured and stabilized before finishing the gypsum panel products or to use solvent-based drywall adhesives. This condition is sometimes called “screw bumps,” due to the unique cause, but the appearance and the repair procedures are the same.

Fastener pops that appear either before or during decoration should be repaired immediately. Those that appear one or more months into the heating season are usually a result of lumber shrinkage and should not be repaired until the end of the heating season.

Fastener pops are repaired by reattaching the gypsum panel product to the framing by driving a new screw or nail of the proper length into the same framing member about 1-1/2 in. (40 mm) from the protruding fastener. Apply sufficient pressure to the gypsum panel to bring the back surface into firm contact with the framing member to which it is being reattached. Remove the fastener or reseal the protruding fastener so that it is just below the face of the gypsum panel. Remove any loose material before treating with joint compound and redecorating.
