MARKETING BULLETIN

REPAIRING DAMAGE/DEFECTS IN A 2-HOUR AREA SEPARATION WALL SYSTEM

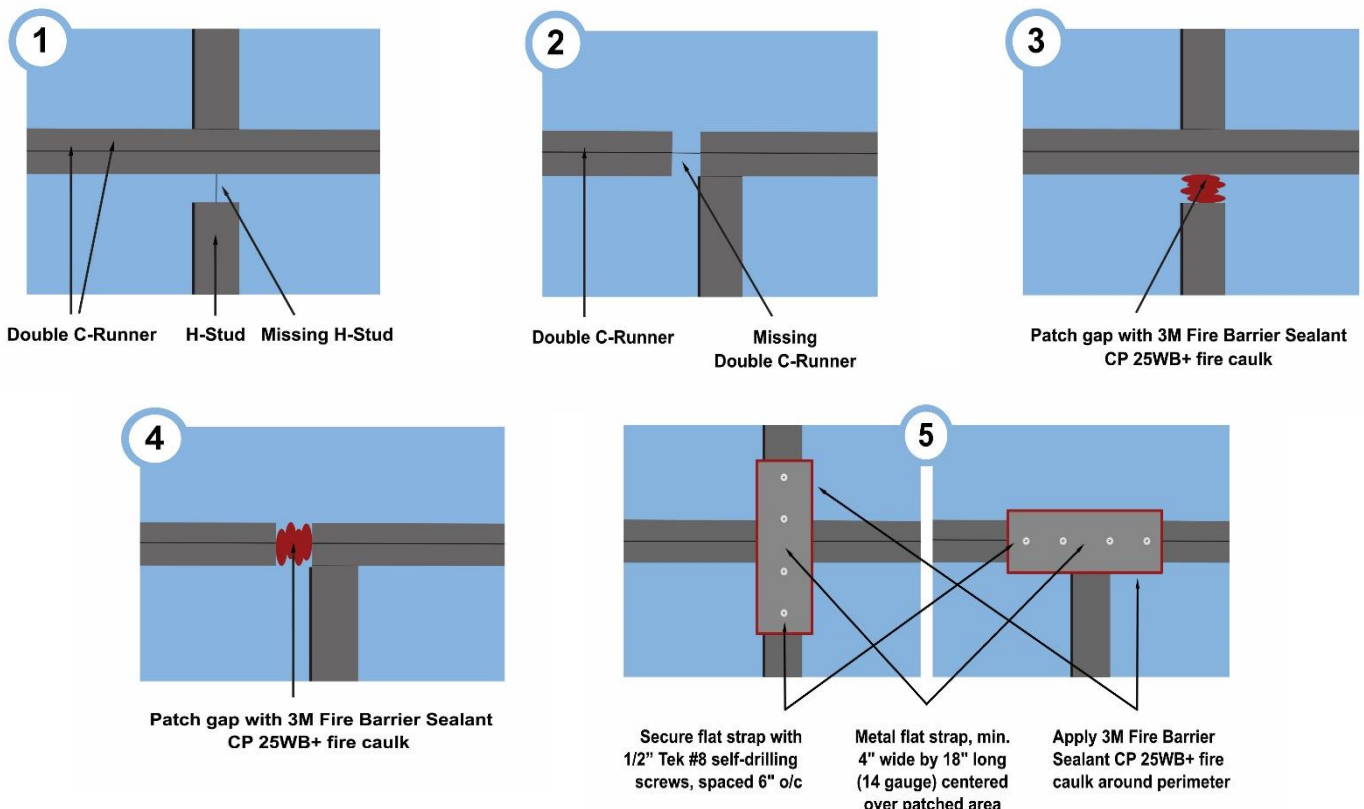
DAMAGE OR DEFECT:	MISSING/DAMAGED H-STUDS OR C-RUNNER TRACK
--------------------------	--

ISSUE: During installation of the ASW System, the vertical H-Studs and or the C-Runner track can be damaged or gaps between framing members can mistakenly be built into the wall (up to 1" maximum). Either of these defects voids the intended 2-hour fire rating.

- REPAIR:**
- ❖ Fill the damaged area or the gap/hole with 3M Fire Barrier Sealant CP 25 WB+ fire caulk
 - ❖ Center over the fire caulking a section of metal flat strap – minimum 4" in width by 18" long (14 gauge)
 - ❖ Secure metal flat strap to H-Stud or C-Runner Track with 1/2" Tek #8 self-drilling screws, spaced 6" on center
 - ❖ Apply fire caulk around the perimeter of the metal flat strap
 - ❖ Duplicate the metal flat strap patch on opposite side of wall
